CENTRAL SECTION PROJECT
C412 Main Works at Bond Street Station
SITE INFORMATION
Volume 3

Document Number: C412-XRL-V3-STE-C125_WS088_Z-50001

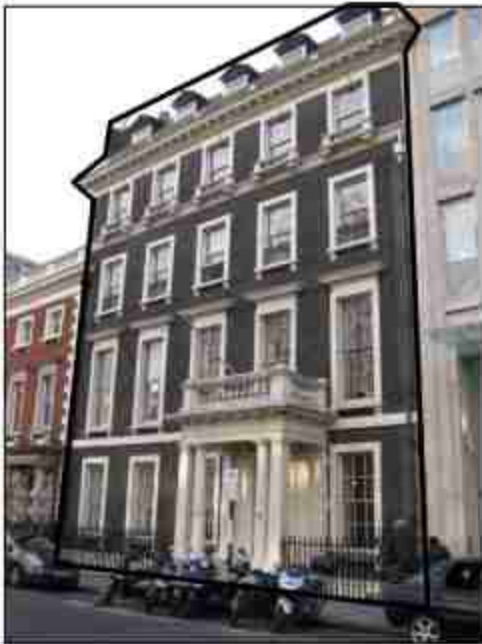
Figure 2.3.3a – 20 Hanover Square

Immediately to the south of the worksite, the grade II* listed number 20 Hanover Square is a substantial terraced town house dating from 1718-20. This building is currently occupied and utilised as office space. The building is made from darkened yellow stock brick with stucco porch and window surrounds. It consists of four storeys, an attic and a basement formed of one level.

The building shared a Party Wall with No. 19 Hanover Square prior to its demolition. Structural supports for the Party Wall have been installed by Others in accordance with the Heritage Deed Particulars for Approval – 20 Hanover Square, and subject to a Party Wall Agreement. Further Party Wall Agreements have been put in place for the piling and capping beam construction, excavation for the Masterplan Shaft, the SCL and bored tunnel works and adaption of the Structural Support for works already completed. The Contractor will need to prepare further Party Wall Agreements as necessary to construct his works adjacent to this Party Wall.

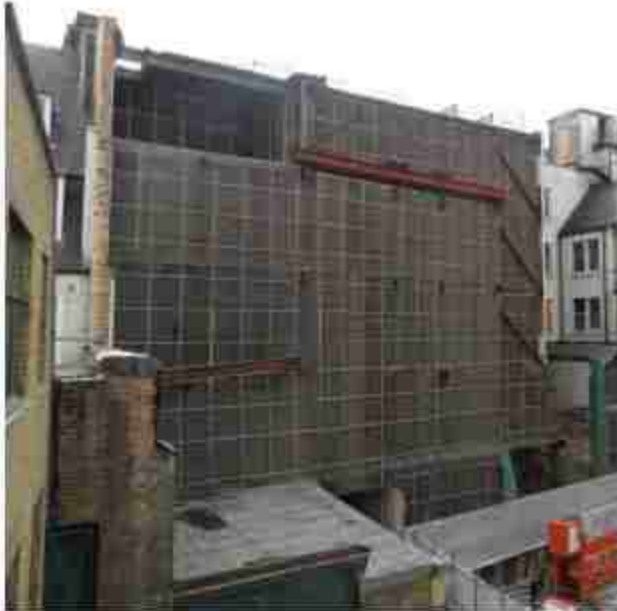
Figure 2.3.3b – Rear of 67-68 New Bond Street

Adjoining the Site to the west is 67 & 68 New Bond Street & 70-71 New Bond Street. The building foundations for these properties are unknown. The basement outline is included in Appendix V3-7.
